Thorne Conservation Area Appraisal

South Somerset District Council
2010

THORNE CONSERVATION AREA APPRAISAL

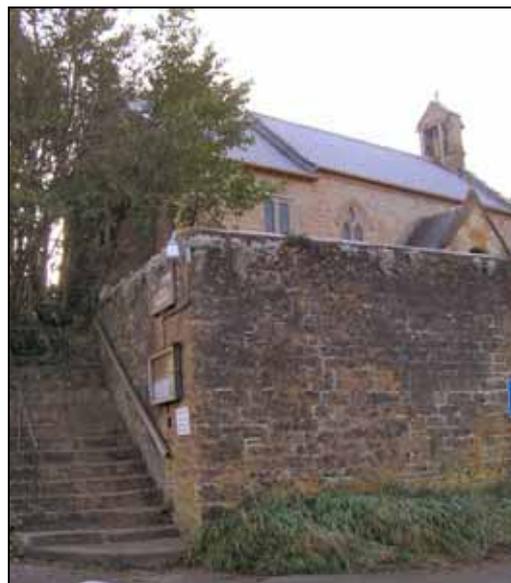
St Andrew's Church is a key building in terms of dominant location and level of land – with high retaining walls, it stands over buildings around it.

St Andrew's Church elevated above the road

the latter's grounds are enclosed with a good low wall with cock and hen coping. Manor Farm yard is bounded with a distinct and unusual fence of massive lias slabs while the setting of the church is characterised by substantial 3m stone retaining walls and accessed via a flight of hamstone steps.

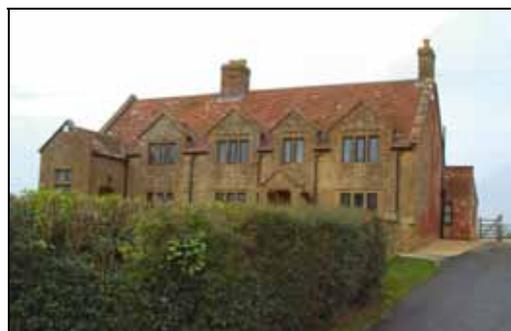
Manor Farmhouse

Prominent too is **Manor Farmhouse** with the good group of farm buildings around their yard below.

The condition of the area is good but the farm buildings at Manor Farm (listed GII) are not in full use and are falling into decay. The interesting cider house opposite Manor Cottages is similarly disused.

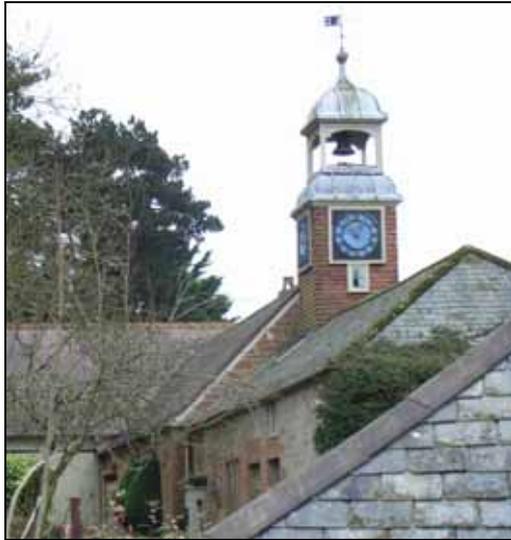
the stables court with its fine clock turret.

Stables clock turret

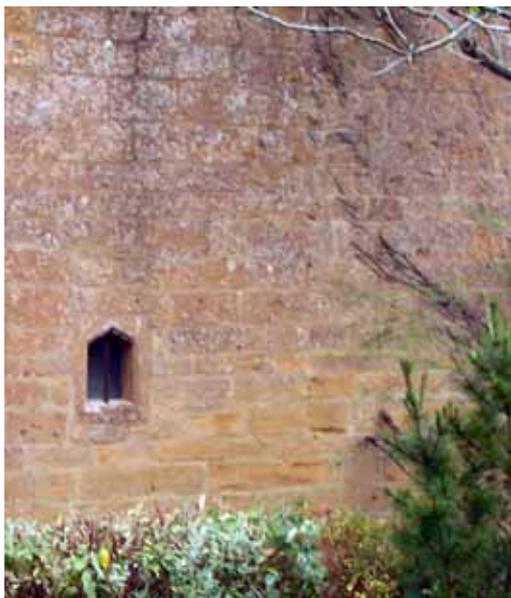
Although the immediately local stone is from the Junction Bed, a pale earthy and shelly Upper Lias limestone only suitable for rubble walling, this is only evident here and there in less prominent locations (eg rear of Manor Farm house). The predominant building material is high quality Ham Hill stone seen in the buildings and boundary walls almost universally throughout the hamlet both as near ashlar faced rubble at Brambley and

Ham stone ashlar

Dairy House Cottages and Thorne Lodge or rougher rubble (The Cottage).

Hamstone water tabling is prevalently featured. Only the Old Rectory is out of context in the use of Lias and this with Hamstone dressings. Thorne House stables and kitchen garden walls introduce red brick, but soft enough to tone with the hamstone. Roofs are slate and clay tile, double roman and plain.

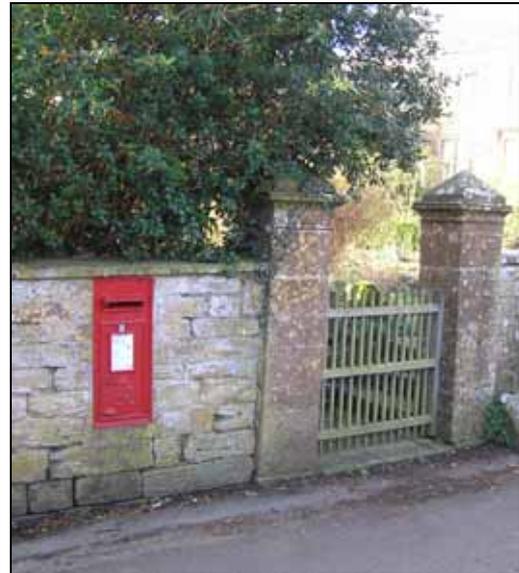
The general use of hamstone throughout for buildings and walls creates visual consistency and cohesion. High quality stone boundary walls and gate piers are characteristic of the lane frontage, and give good enclosure. A long length of herringbone walling, unfortunately poorly repaired in contrasting coursed masonry in places, defines the open ground west of Thorne House while

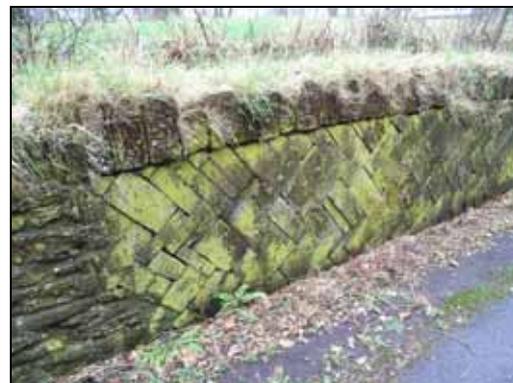
Herringbone pattern wall

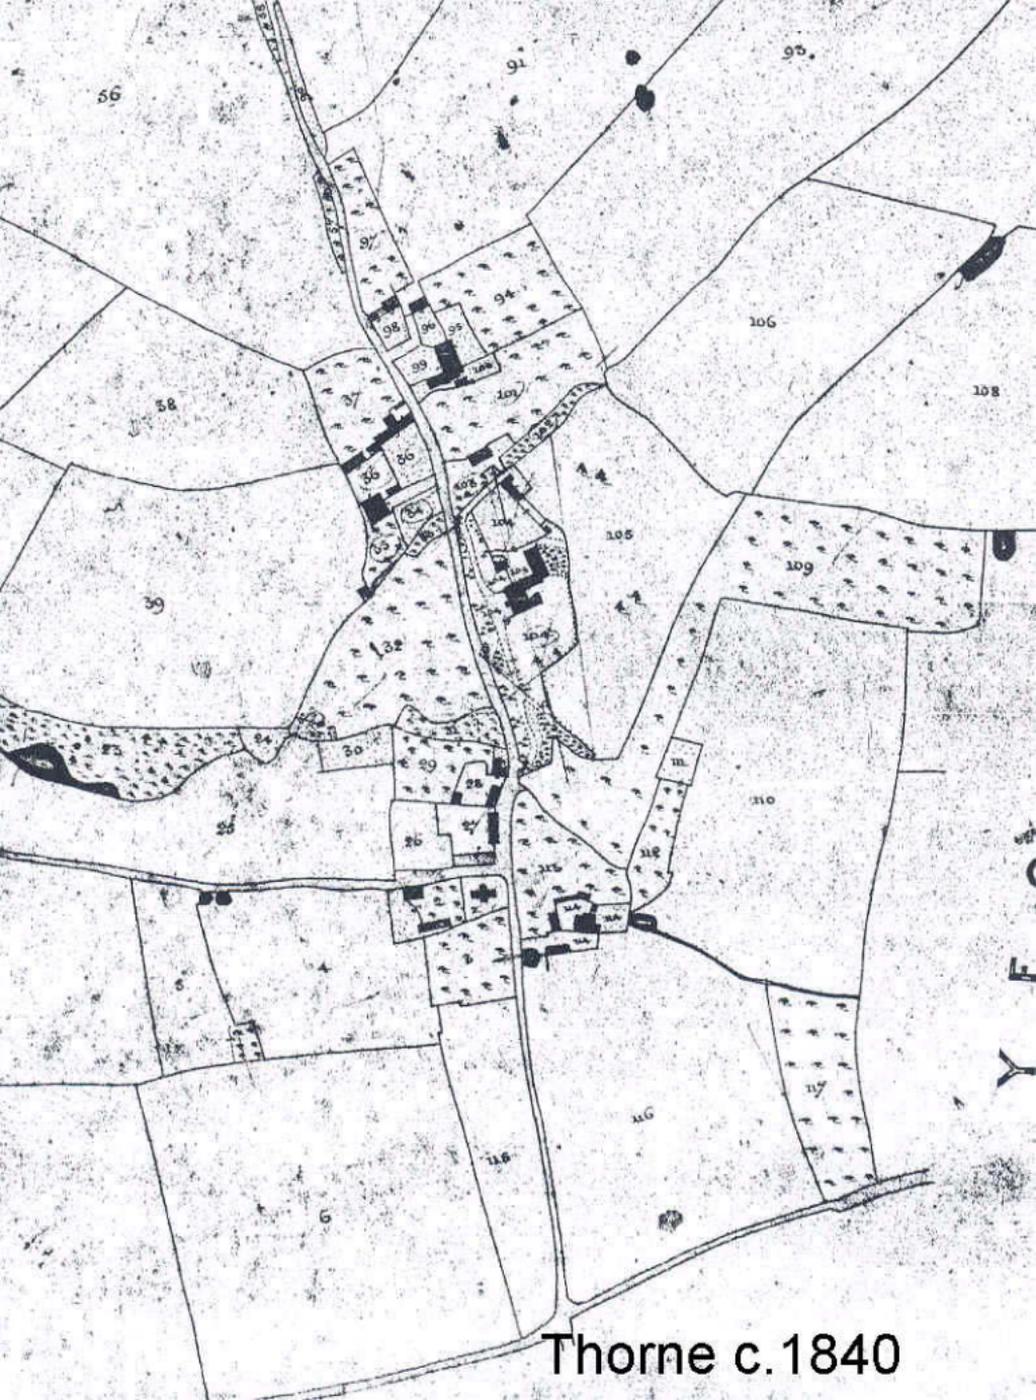
Thorne c.1840

The hamlet has remained largely unchanged for over 150 years; the tithe map of c1840 shows few major differences to the map of today. The road alignment is reputed to have been altered to run further away to the east of the manor' east front in the C18. Very few buildings appear to have been lost or added since that time. Thorne House was rebuilt or substantially altered on the same site, its outbuildings extended in the 1880s, the Rectory was new built on a plot west of the church in the later C19 but the overall form of the village has remained consistent save change to the setting though demise of the orchards that feature prominently in the 1886 map. This shows Manor Farm, Dairy House Farm, Higher

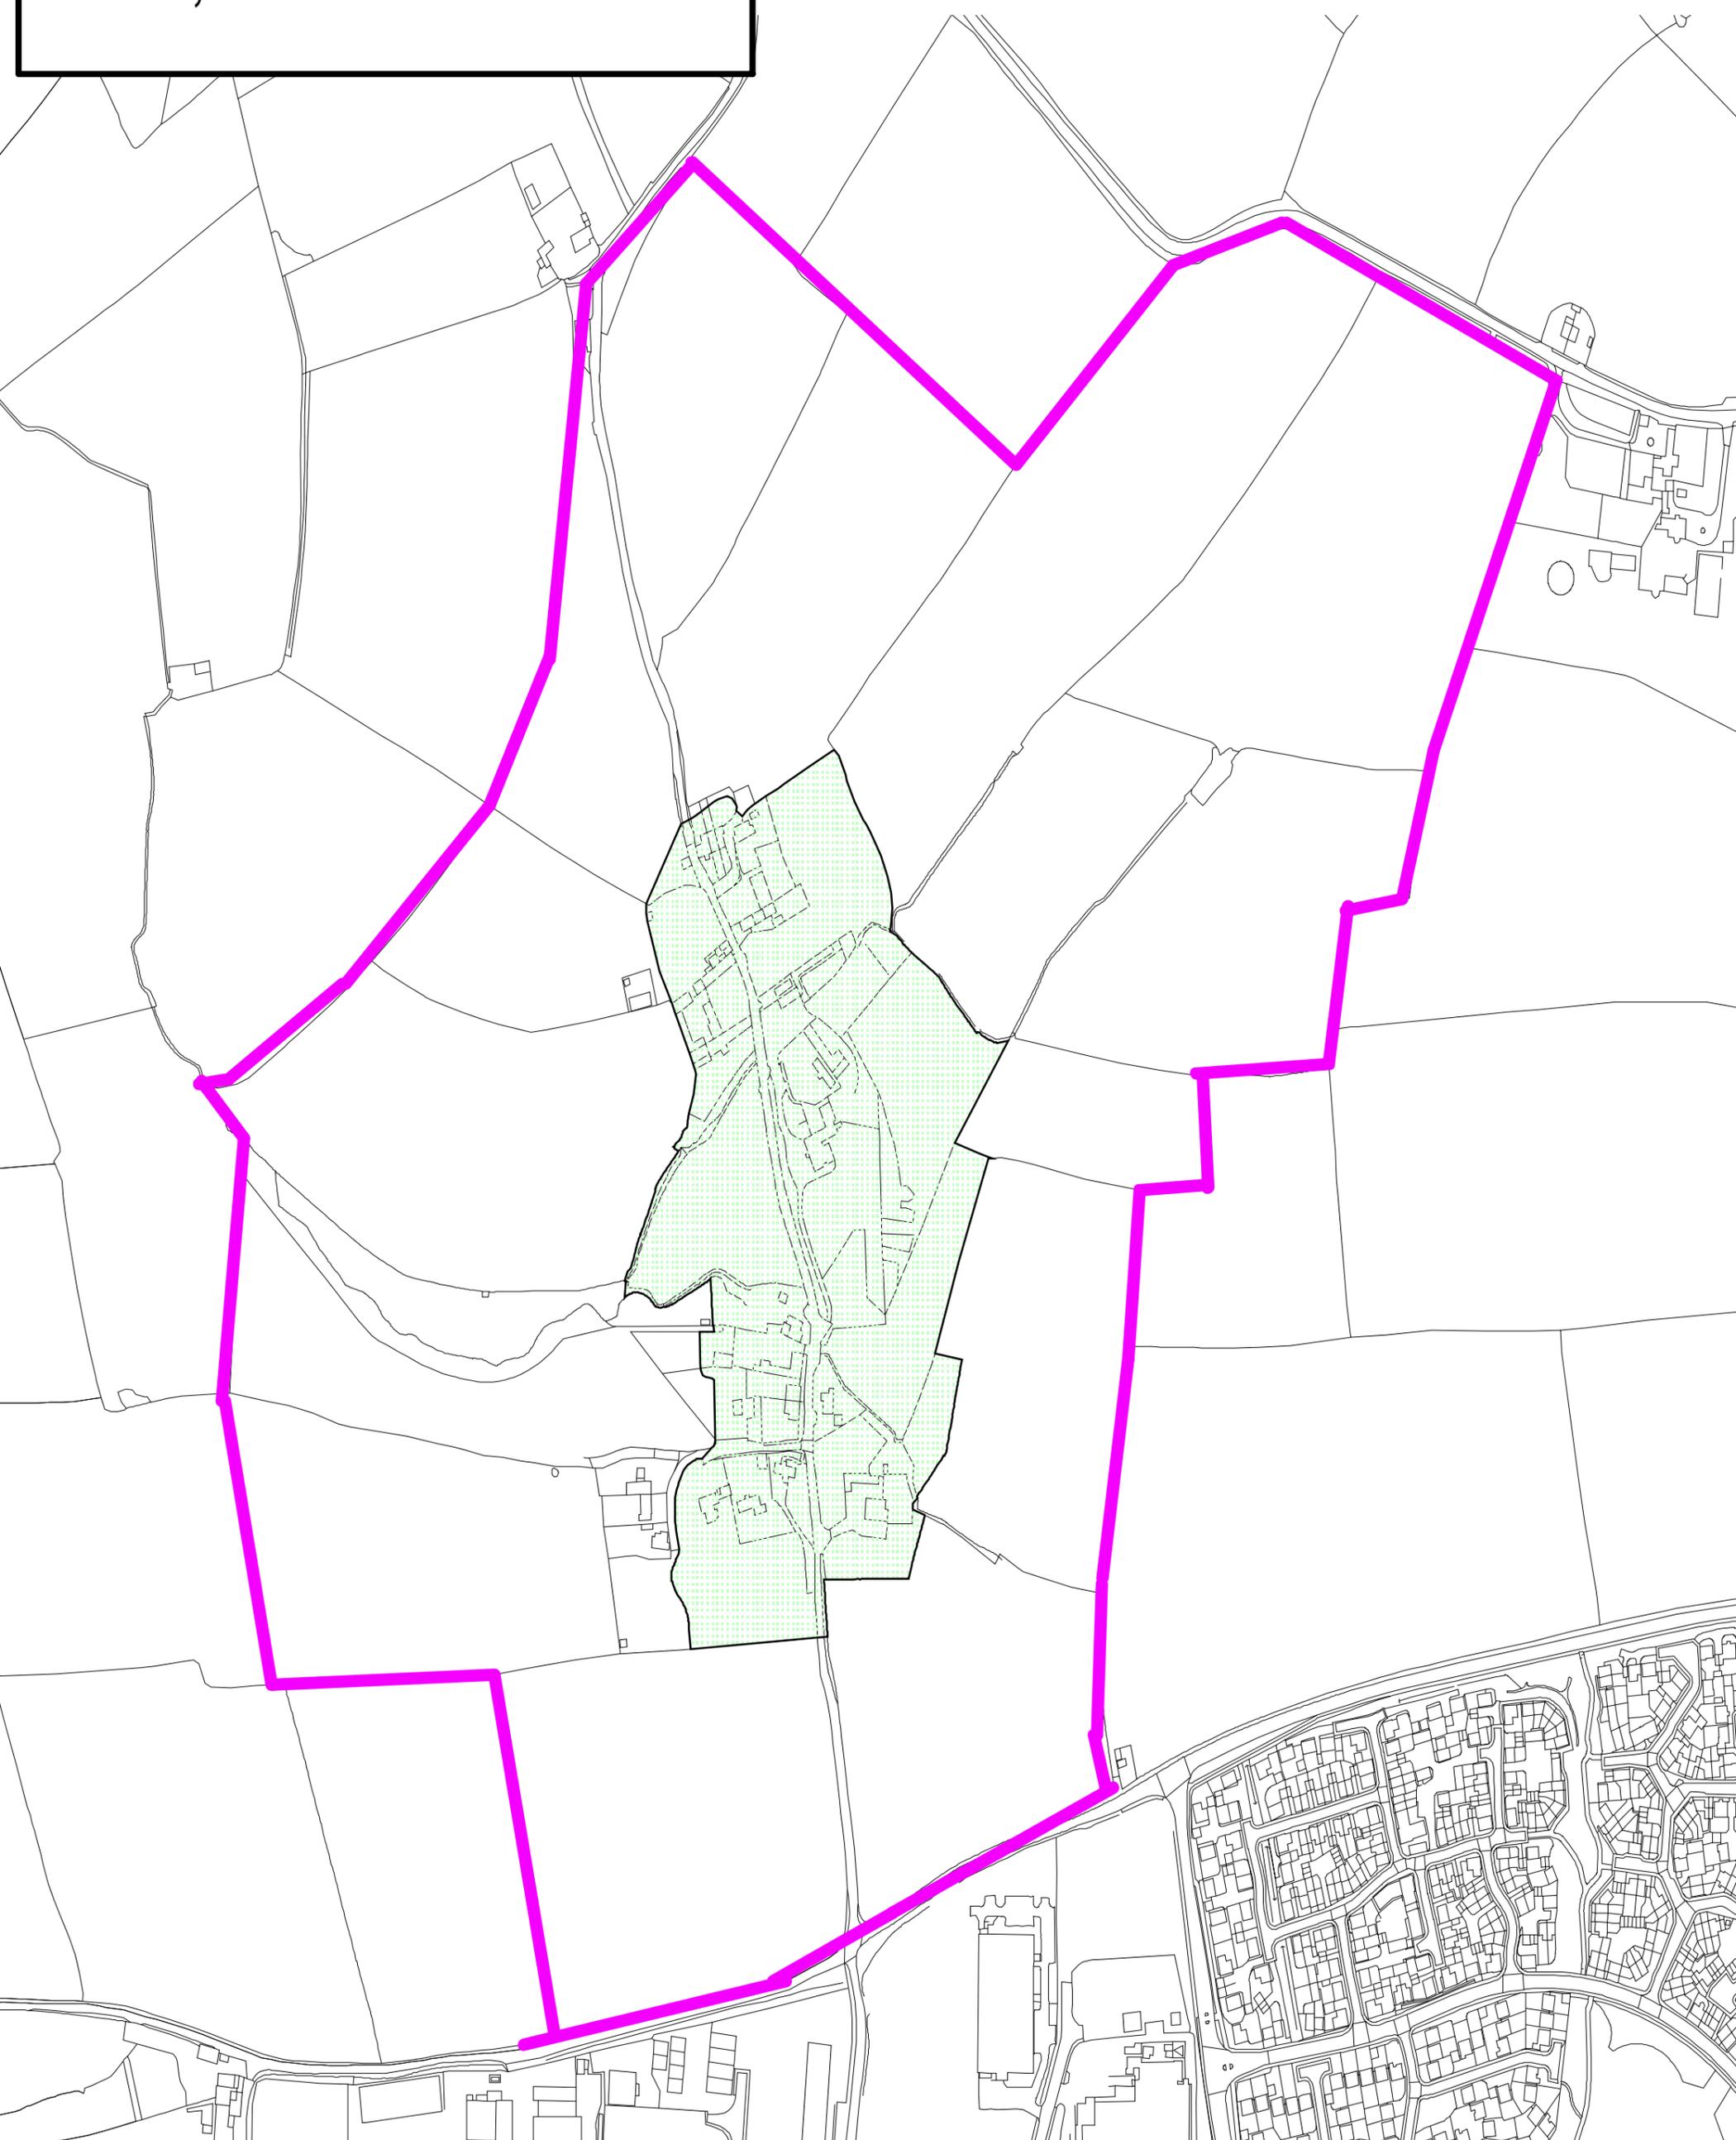
Thorne Coffin Conservation Area

Showing the setting of Conservation Area and the boundary of Conservation Area

The setting is identified in relation to the national and local planning policies in PPS5 'Planning for the Historic Environment' and the South Somerset Local Development Framework. Its extent has been refined by SSDC from the initial work contained in the Historic Environment Assessment of Yeovil Periphery. The setting is mapped at the end of this document.
