**Buildings at
The Cattle Market
Yeovil
Somerset**

Wildlife Assessment

May 2008

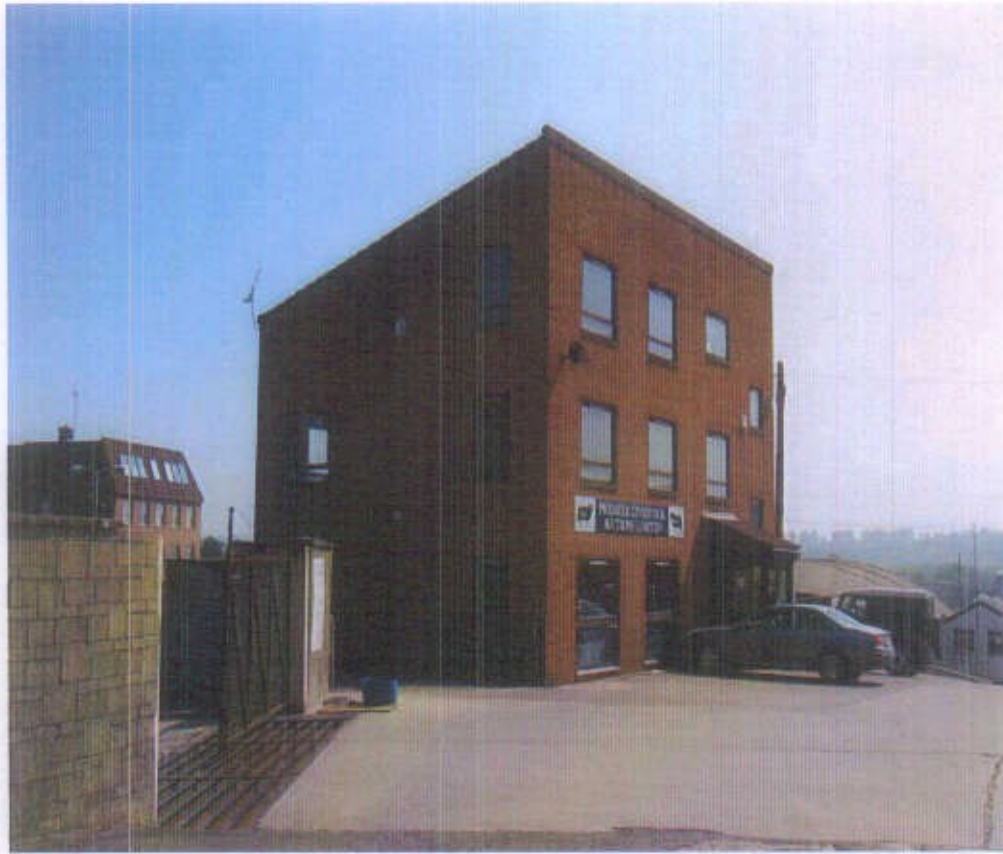
This brick built 3 storey building has a single pitch roof covered in clay tiles with a felt underlay. It has a small accessible roof void.

the Office Block. The potential bat roost site identified was under the preformed tiles overhanging the gable end walls. No other potential roost sites were identified.

View of Office Block.

- 6.1. Caution must be taken when **all** roofing materials are removed, particularly those above the ridges and walls. They must be removed by hand and checked for roosting bats before stacking. Should a bat be discovered work must be suspended and expert advice sought. The bat should only be moved by a competent person if it is in danger. Work which could further disturb the bat should be suspended until expert help is on site.

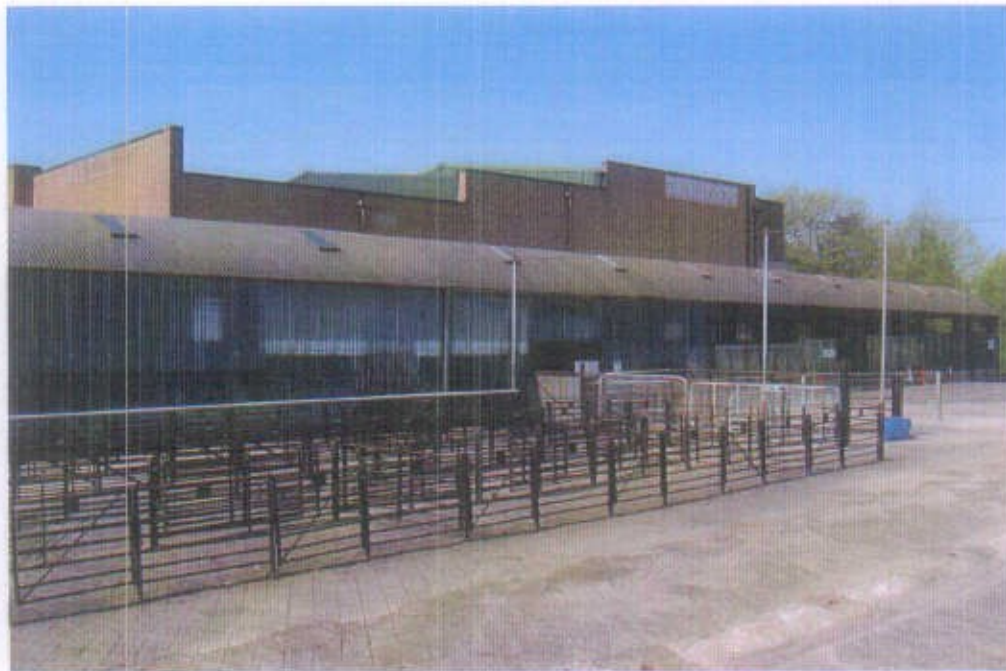
These single storey pens have semi-circular roofs over a metal frame. The roofs and walls are clad with corrugated metal sheeting and some clear plastic sheeting. Parts of the walls along the northern elevation are open sided.

View of Sheep Pens.

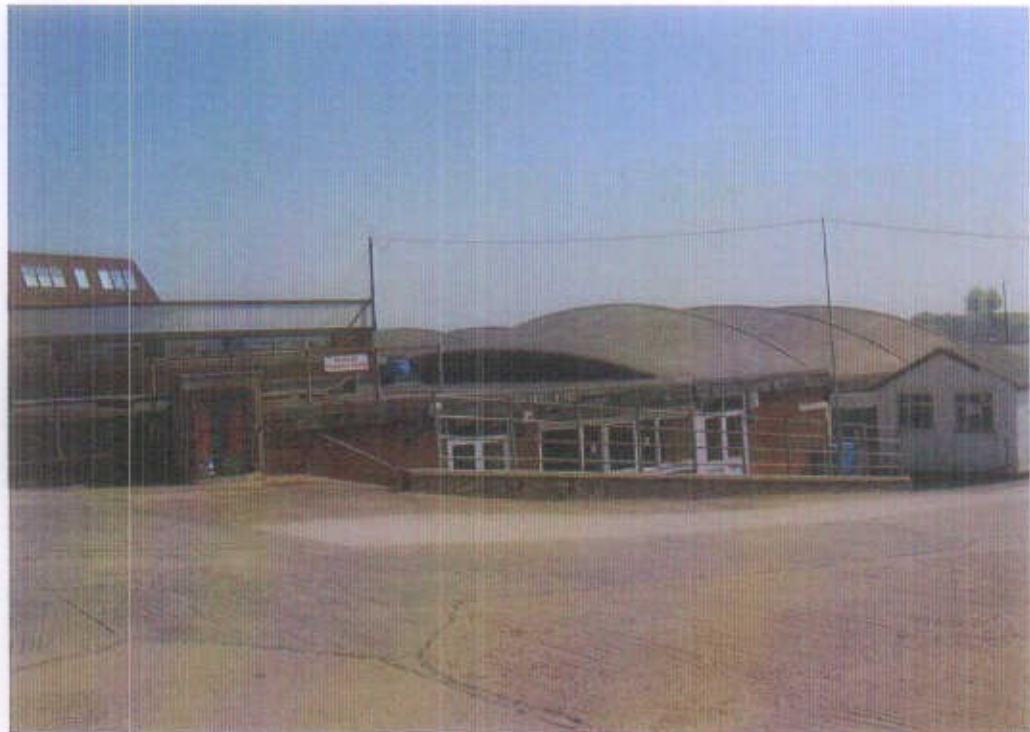
The cattle pens have a series of arched roofs covering them, although some sections have been removed due to decay. These roofs have a bitumen felt covering and timber lining. The walls have a cement render finish.

The Dairy Ring and adjoining café area have flat roofs which are also bitumen coated. Internally a suspended ceiling exists which has partly been removed.

View of Dairy Ring, Café and Cattle Pen roofs.
